Air India Flight AIC171

A Plausible Hypothesis

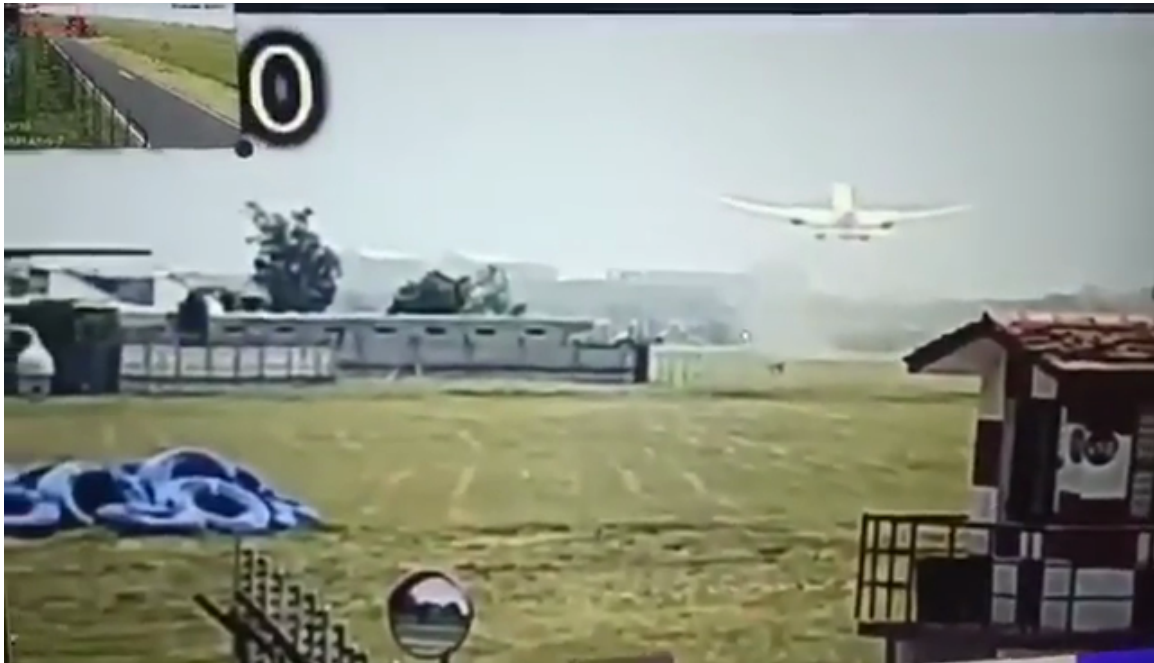
Airport Security CCTV at 08:08:45.5 UTC Frame 647

Smoke can clearly be seen in both screenshots. The smoke is possibly related to the brakes overheating during the take-off roll.

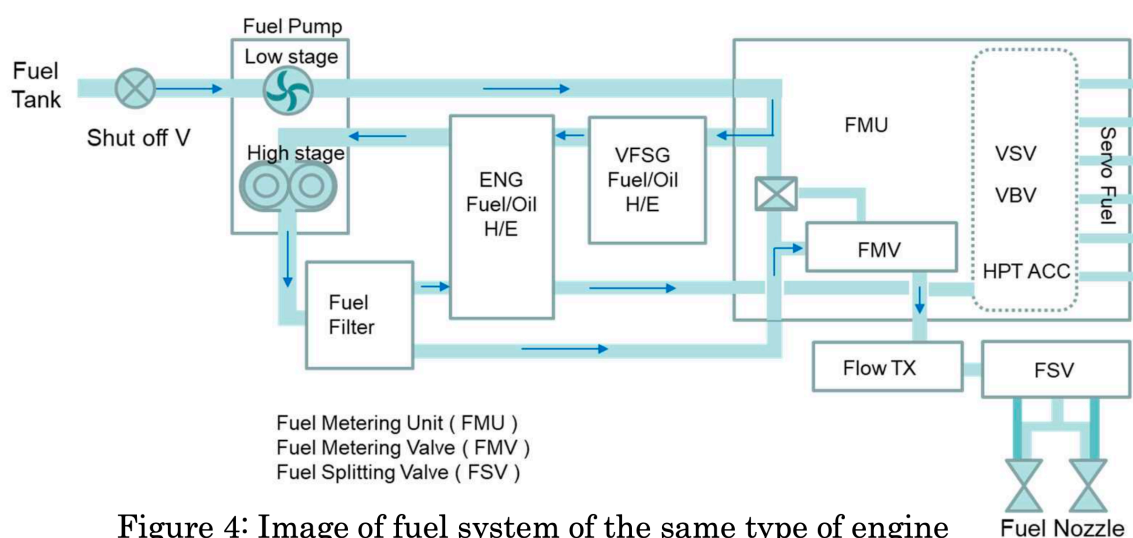
Figure 4: Image of fuel system of the same type of engine

(b) The Fuel system can cause Engine shutdown, but again both Engines were successfully relit. Any issue with the Fuel System must have therefore been intermittent and cleared quickly to allow relight.

The major components of the Fuel System for the GEnx-1B engine are depicted below. The fuel valves, pumps and filters had to be functioning for a successful relight.

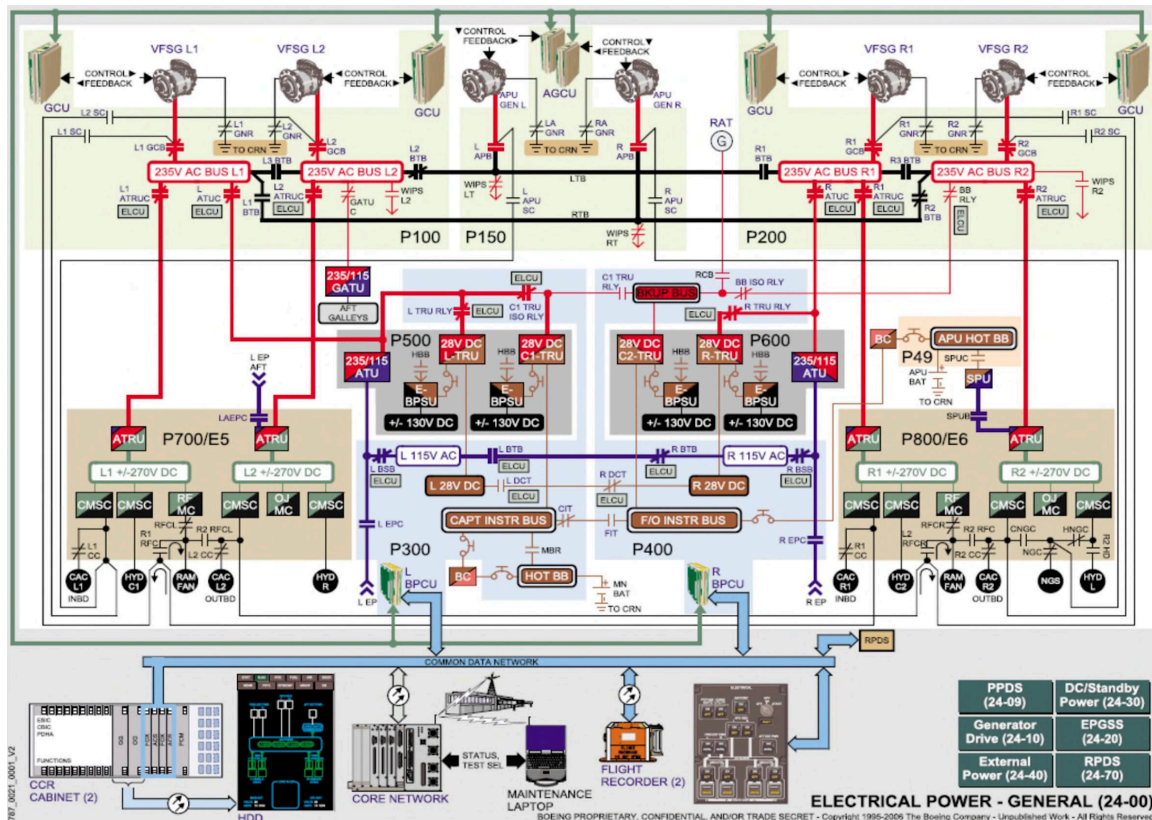
Water ingress into the EE bays can produce intermittent shorts across multiple panels.

P100, P150, P200, P700/E5 and P800/E6 are in the Aft EE Bay.

P300, P400, P500 and P600 are in the Forward EE Bay.

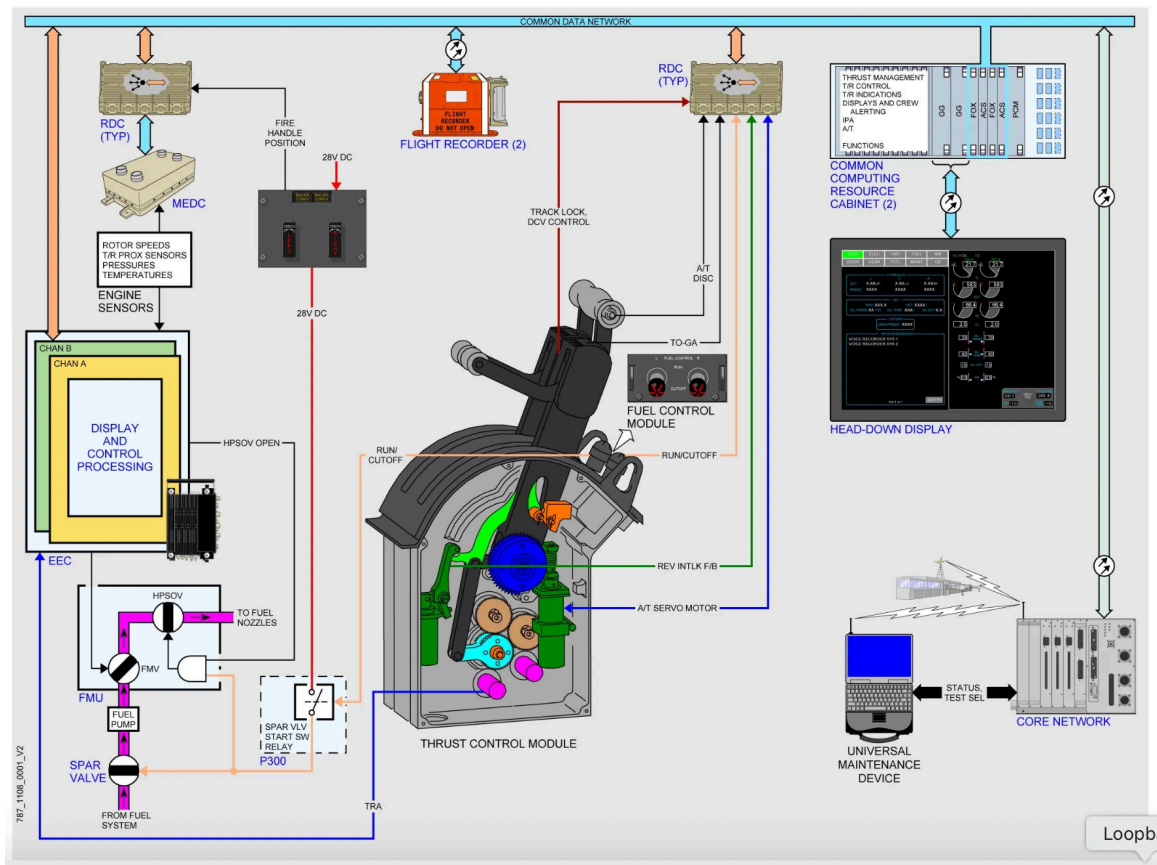
The Fuel Control Module RUN/CUTOFF Switches are connected to the SPAR Valve Start Switch Relay (Left and Right) and to the Remote Data Concentrator (RDC) (Left and Right).

The two Fuel Switches are powered by separate Electrical buses and each switch has two separate signal paths. The possibility that all 4 signal paths failed simultaneously is negligible.

A single point intermittent common-mode electrical failure up stream of the Fuel Switches cannot be ruled out. An intermittent common-mode fault (e.g., in the fuel control switch assembly or in shared wiring upstream of the relays or the RDCs) that could command both fuel valves to close simultaneously is feasible.
