Air India Flight AIC171

A Plausible Hypothesis

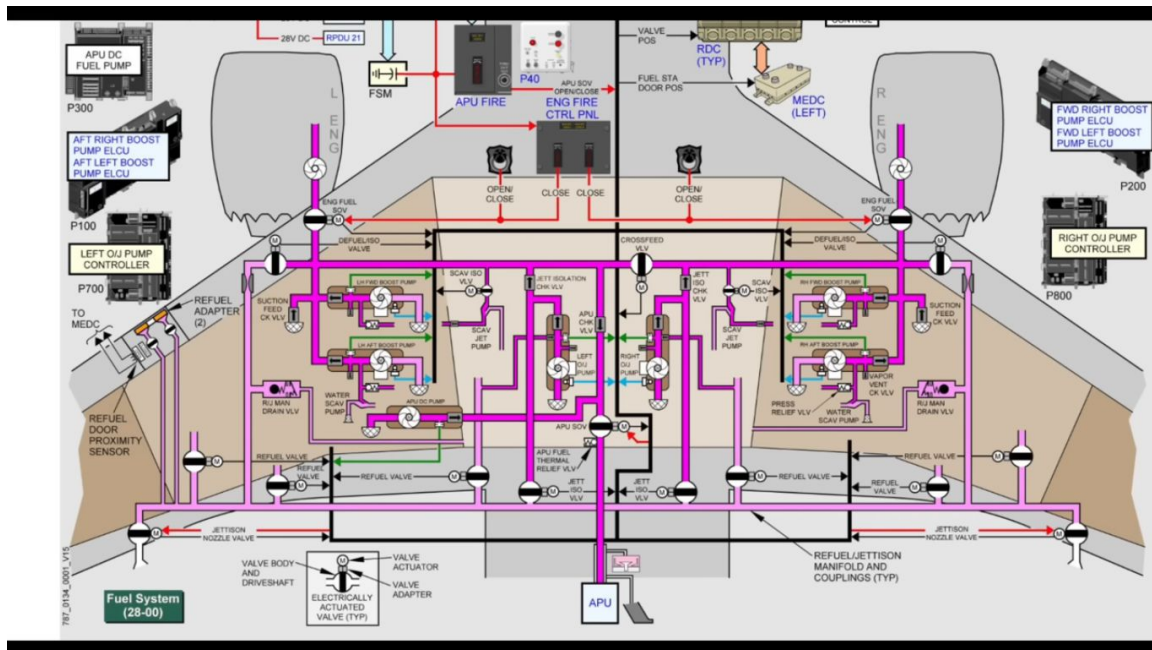
Figure 4: Image of fuel system of the same type of engine

Neither the Fuel Switches were permanently CUTOFF, nor the Fire Handles were operated as evidenced by a successful relight of both engines.

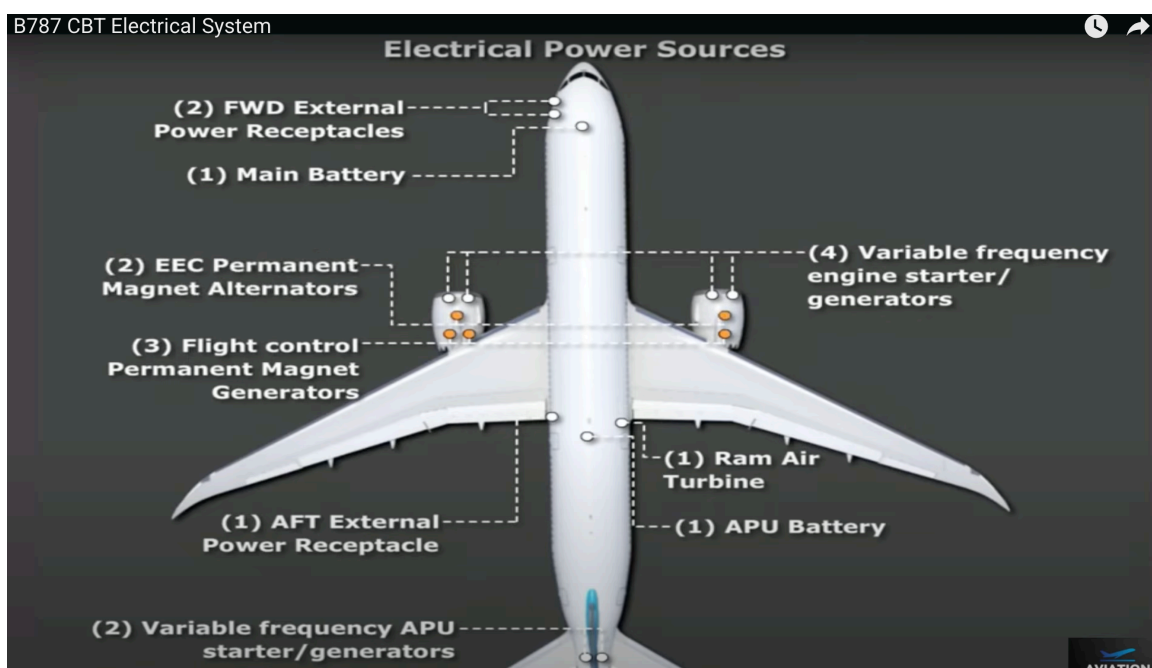
Here is an overview of the Electrical Power Sources:

Power-panel/contactor logic transients (“chatter”) in the primary distribution path can momentarily de-energise multiple downstream buses.

Water ingress into the EE bays can produce intermittent shorts across multiple panels.
